Manhole Inspection Summary

Manhole # S43M__027MH

Insp Date: **6/6/08 7:46 AM**

Location Address: **821 Thames st**

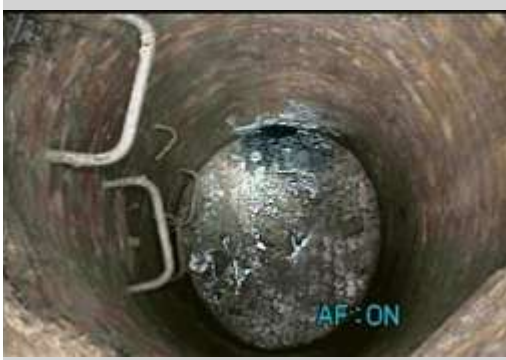
Top View

top view & steps

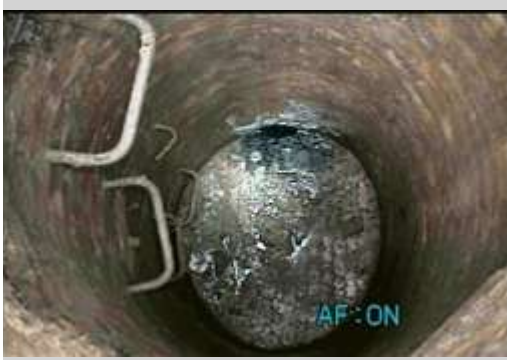
Defect 1

Missing: **1**

☒ **Corroded**

steps

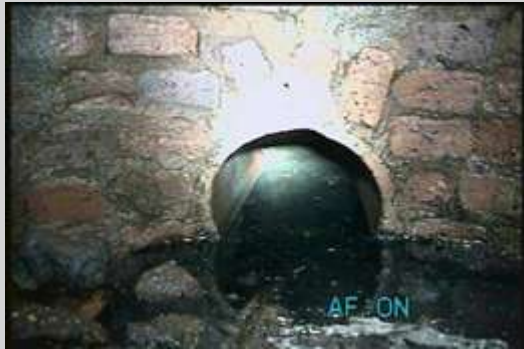
12 O'Clock Outflow

8 in. Circular Gravity Sewer
Pipe Out @ 12 O'Clock

Infiltration: **None** Pipe Seal Cond: **Unknown**
